TransEnergy Inc., Lucey Site, Marshall County, WV

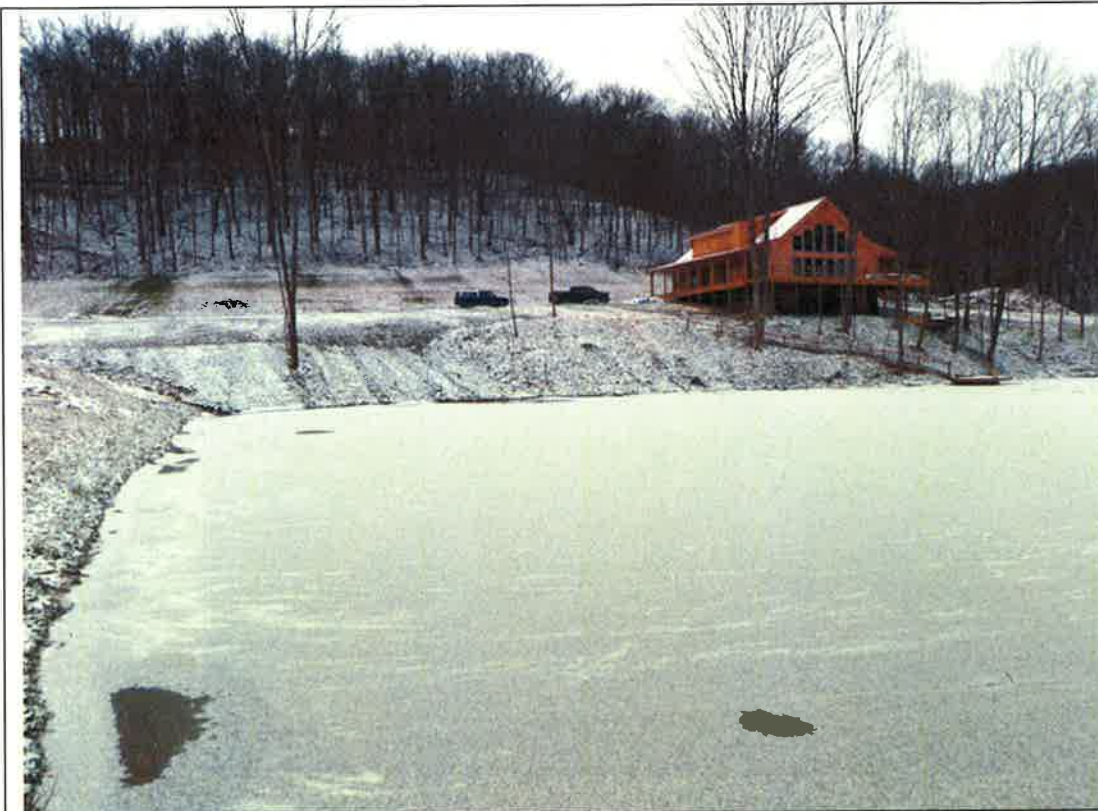
**Photo ID:**  
ACOE Photo 007

**Description:**  
Lucey  
impoundment

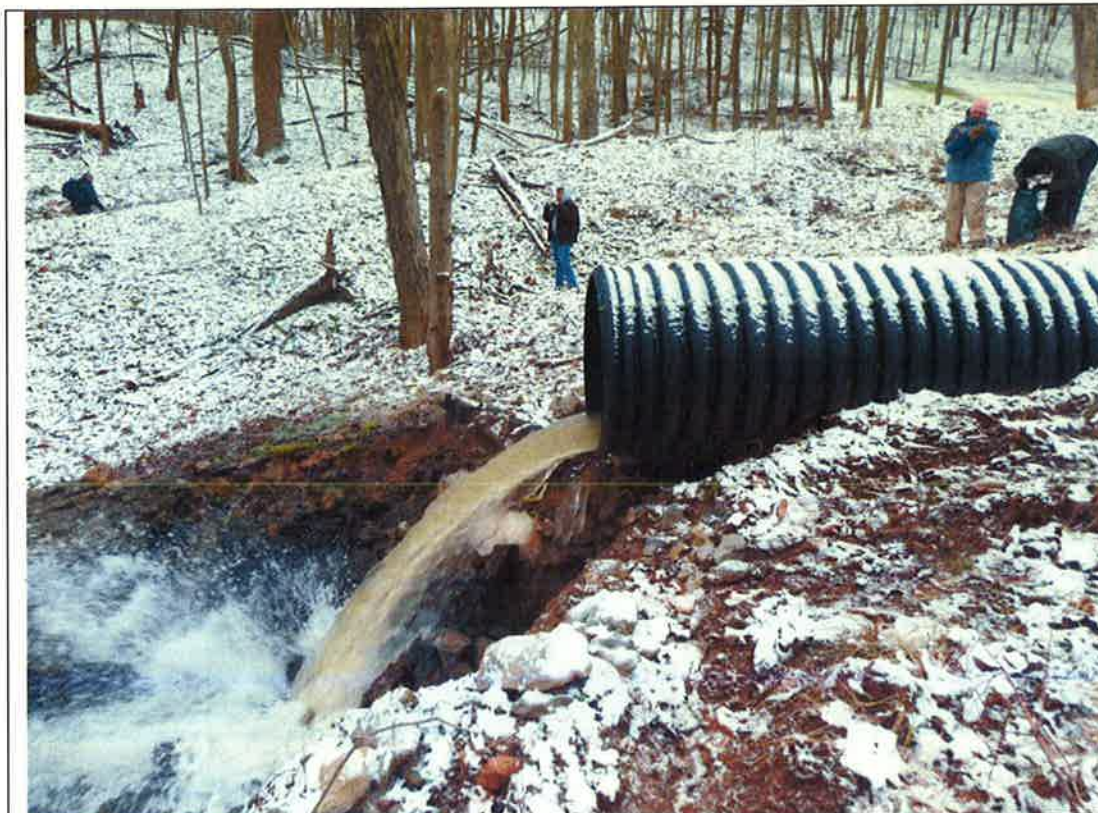
**Photo ID:**  
P1000680

**Description:**  
WC1 Outlet from  
impoundment

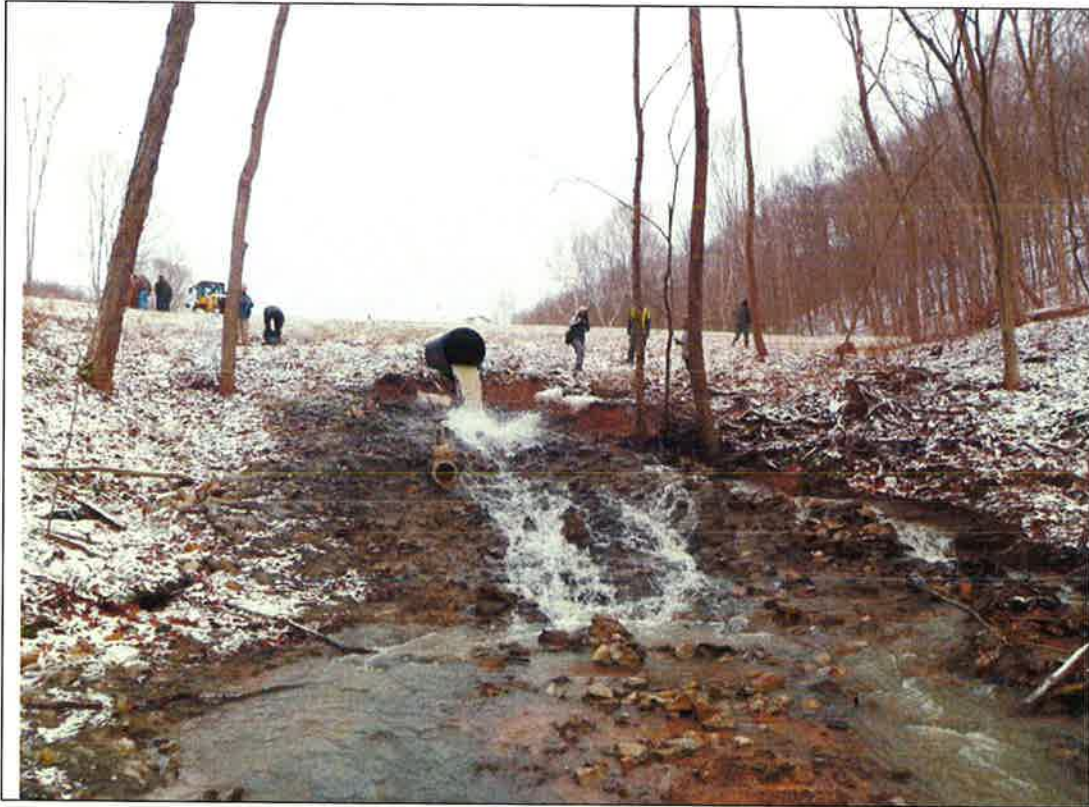
ACOE Photo 002

Dam for  
impoundment

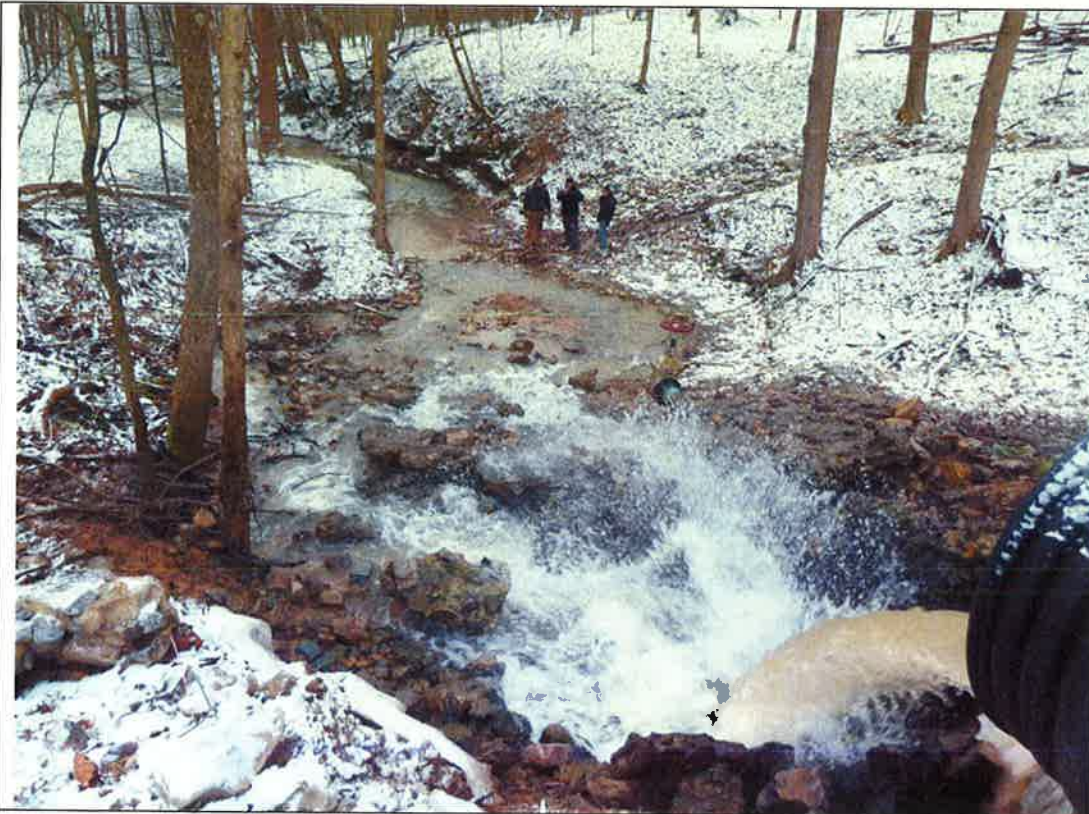
P1000681

Outfall discharges  
into streambed  
stabilized by  
concrete.

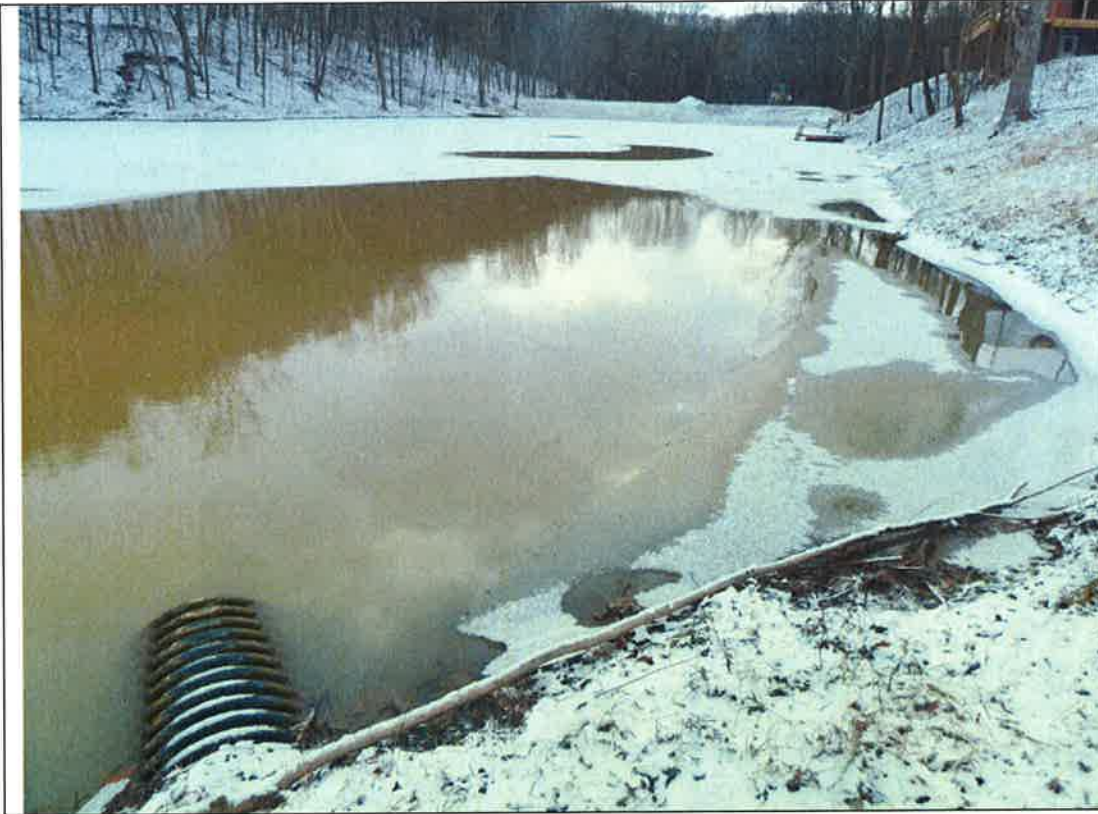
P1000688

WC 2 outfall  
(looking towards  
berm)

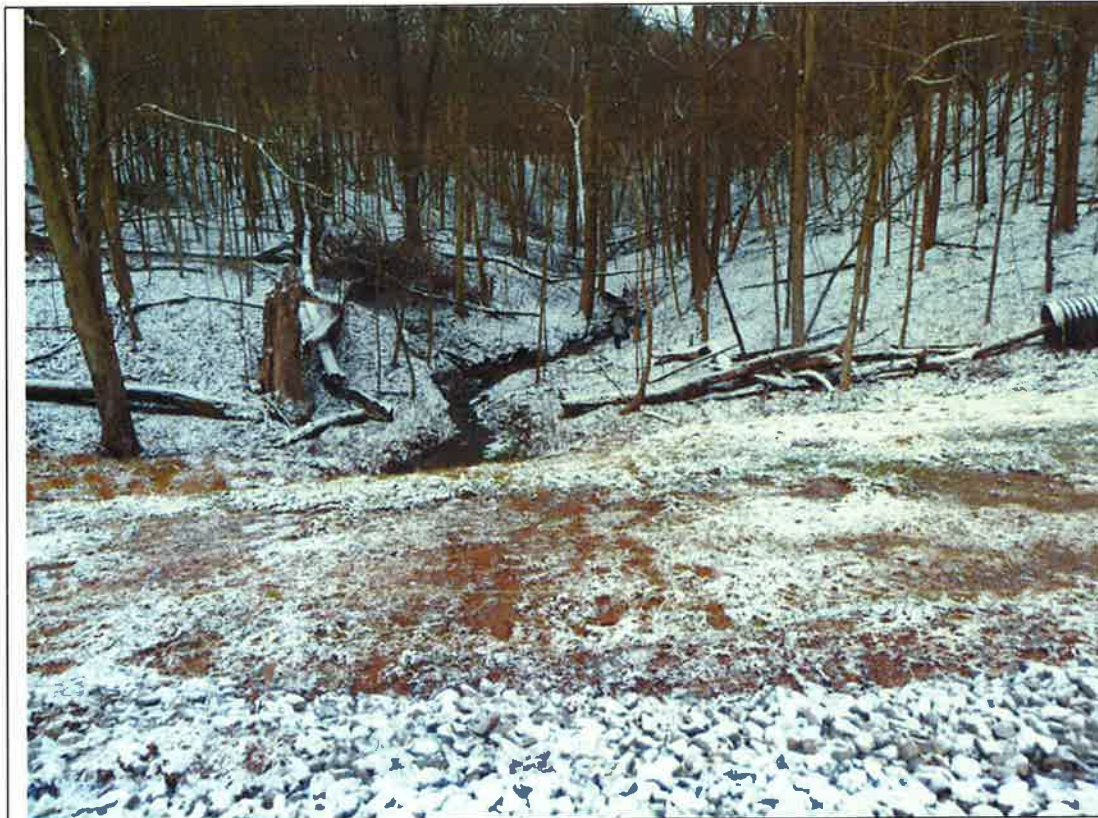
P1000690

WC2 with fill in  
the foreground

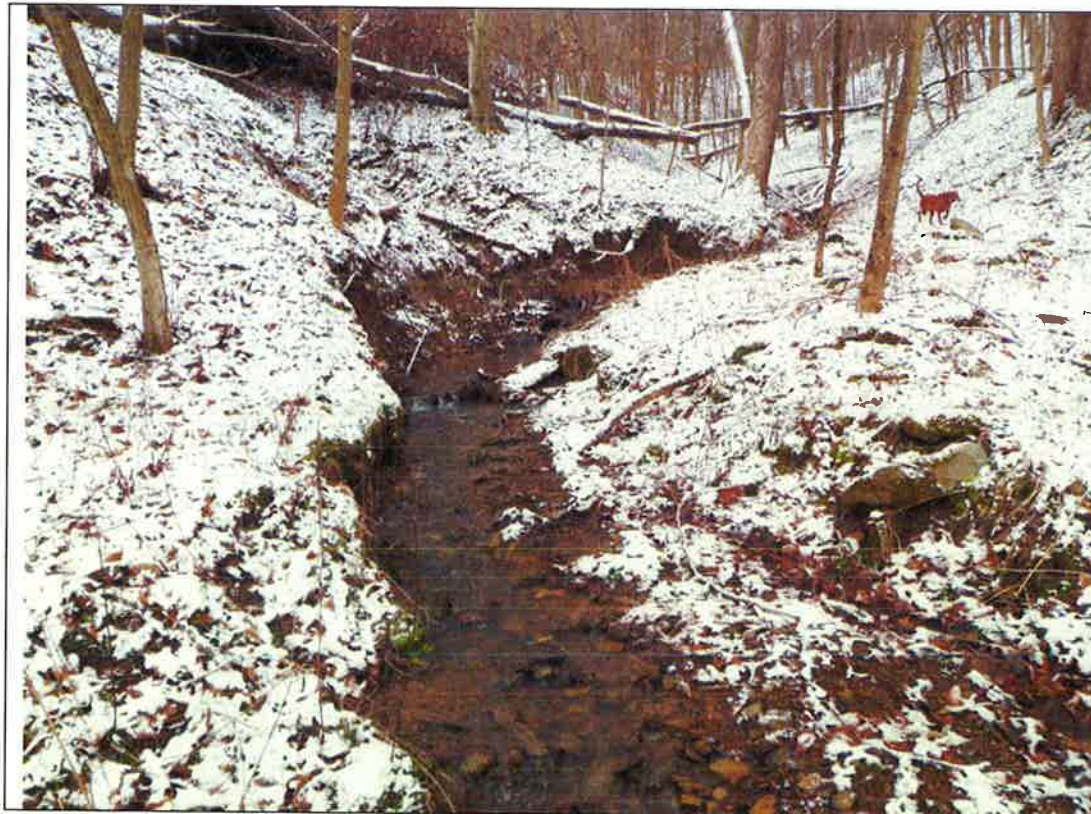
ACOE Photo 011

WC2 looking  
upstream

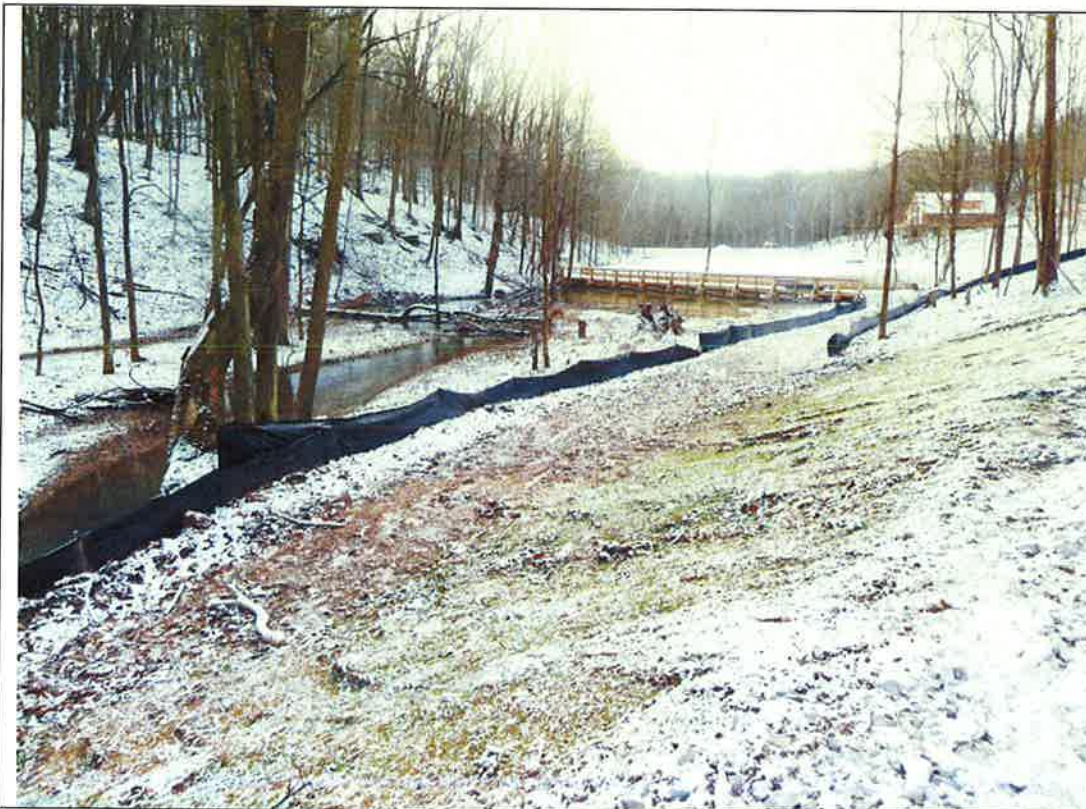
P1000703

Looking  
downstream  
toward  
impoundment in  
impact area. Note  
bridge and  
backwater  
impacts.

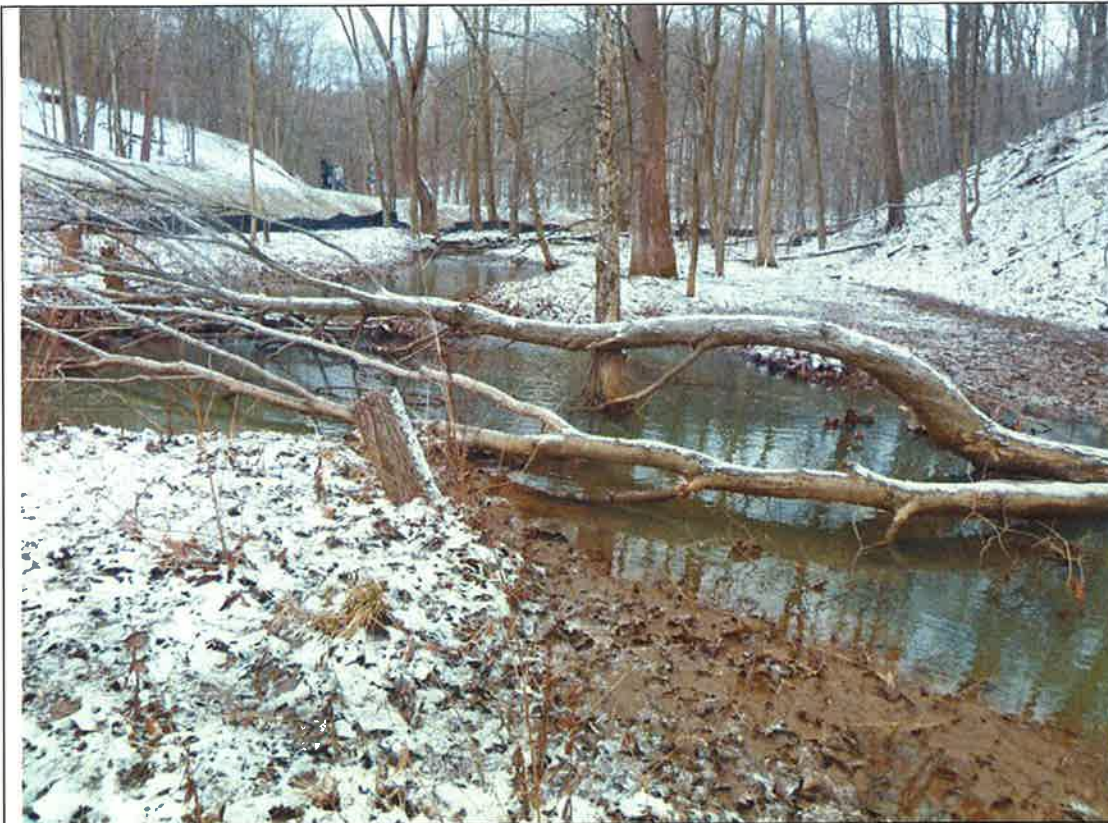
P1000704

Backwater area  
of WC1 looking  
upstream.

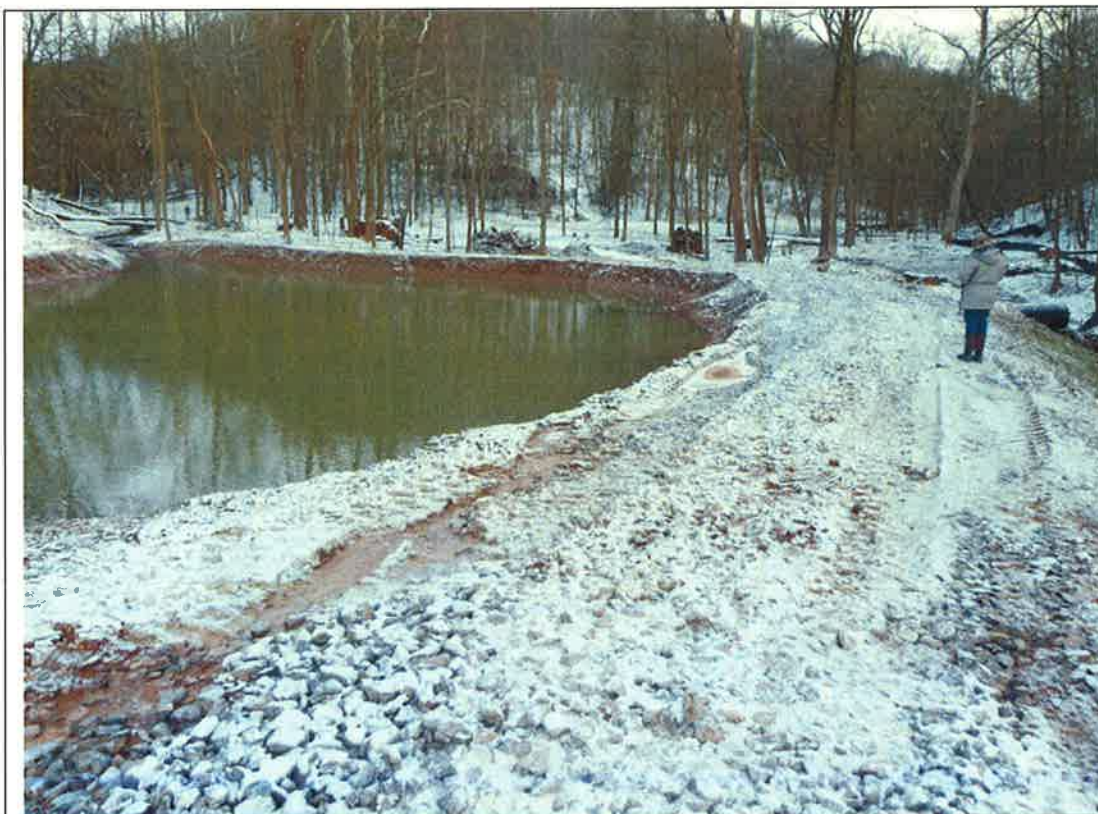
P1000693

Impoundment on  
WC3.

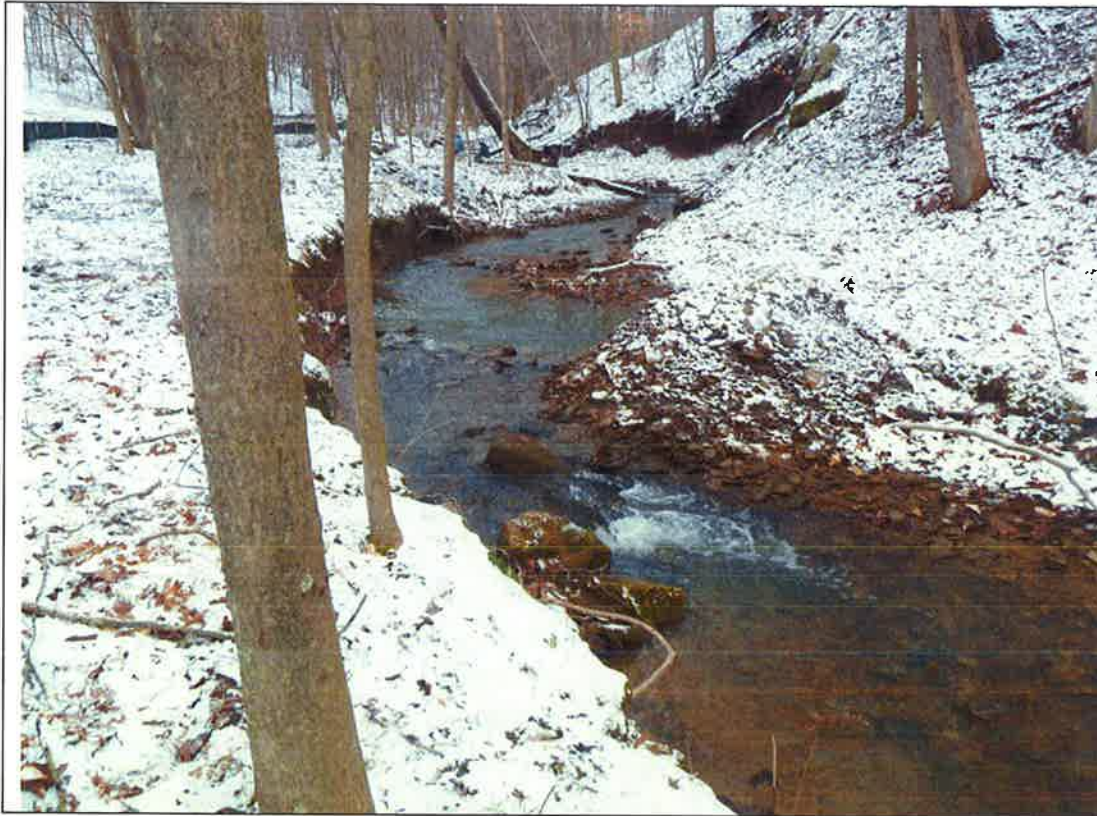
P1000701

Outlet from WC3 impoundment. Confluence with WC1 can be seen.

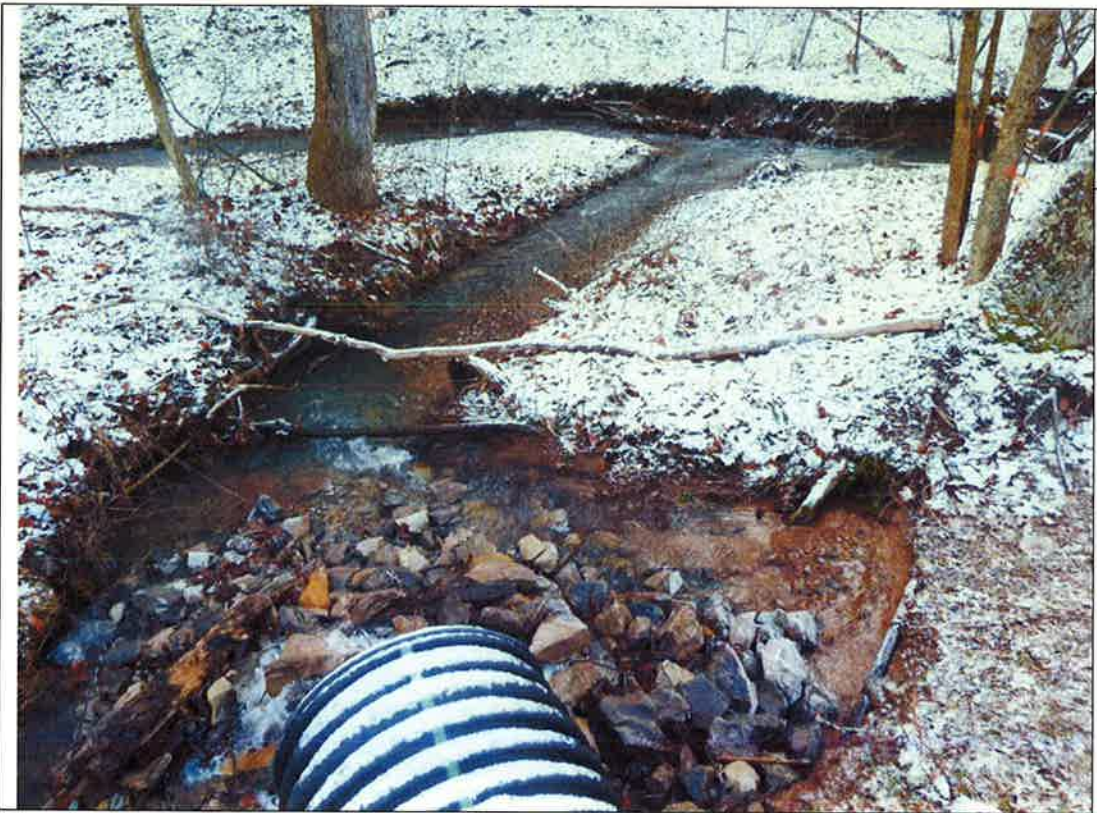
P1000696

Outlet from WC3 impoundment. Confluence with WC1 can be seen.

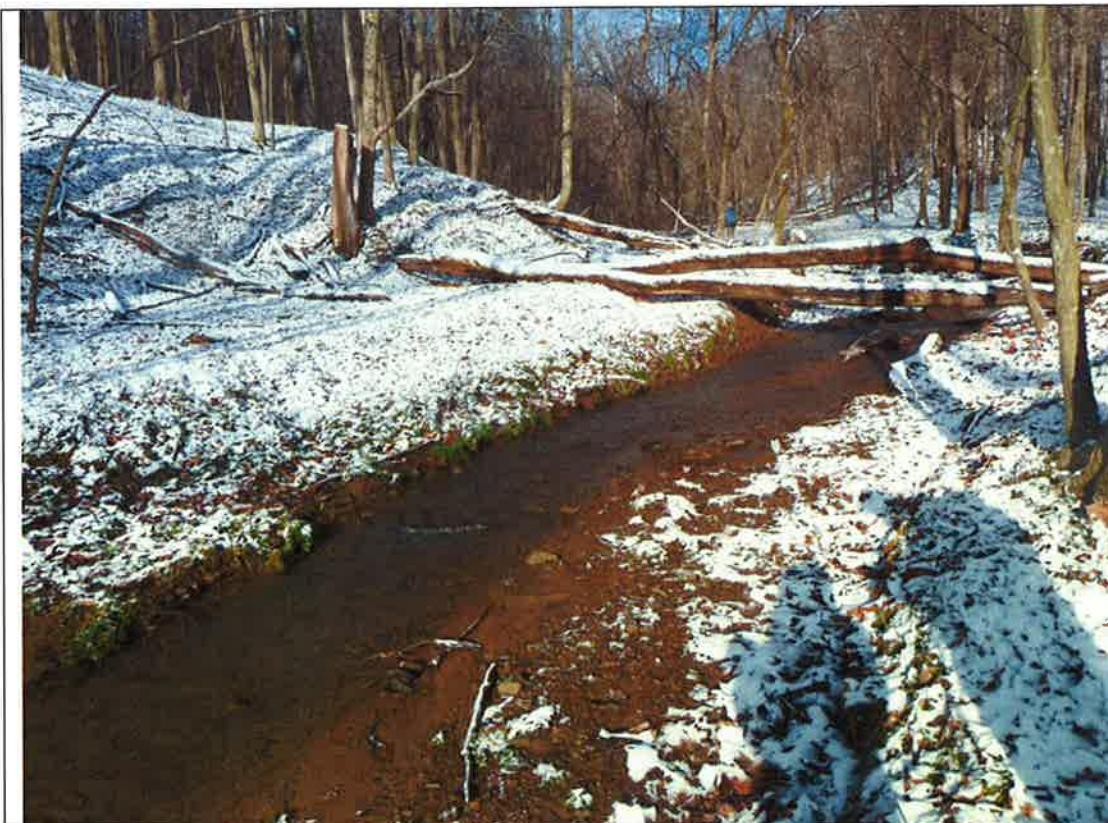
P1000698

Looking  
upstream of  
WC3  
impoundment.

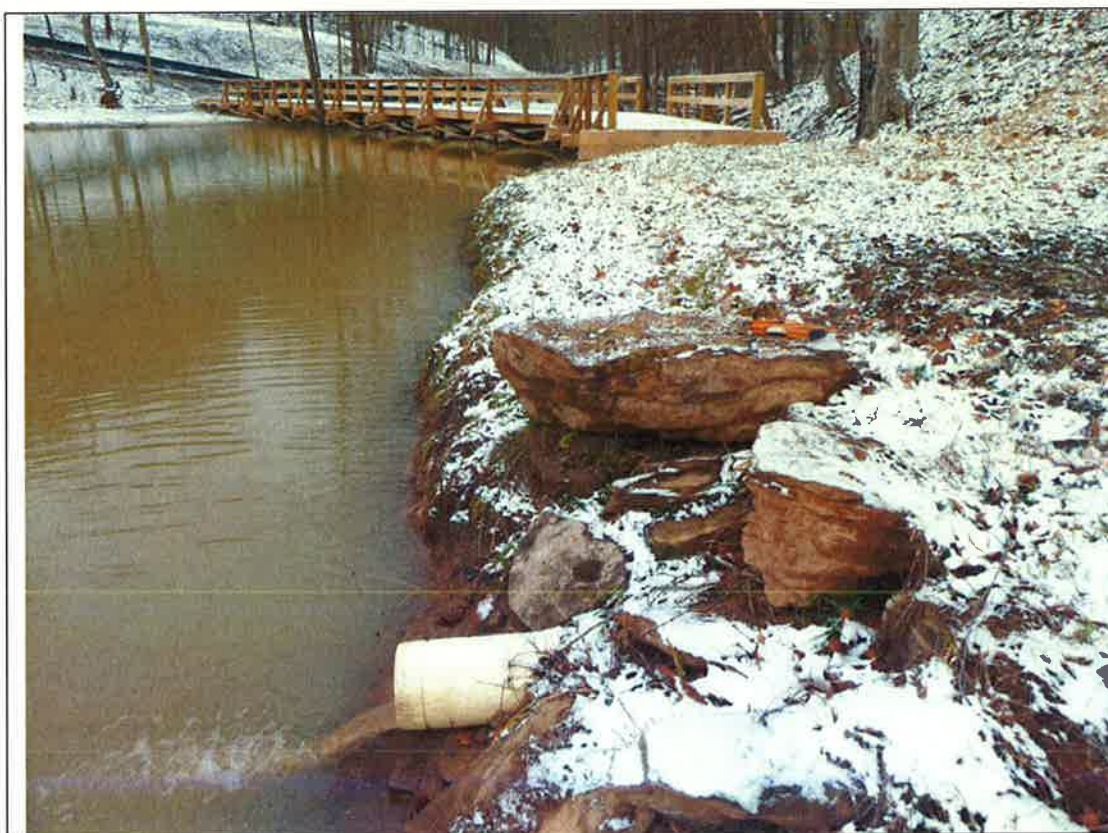
P1000705

WC4 outlet

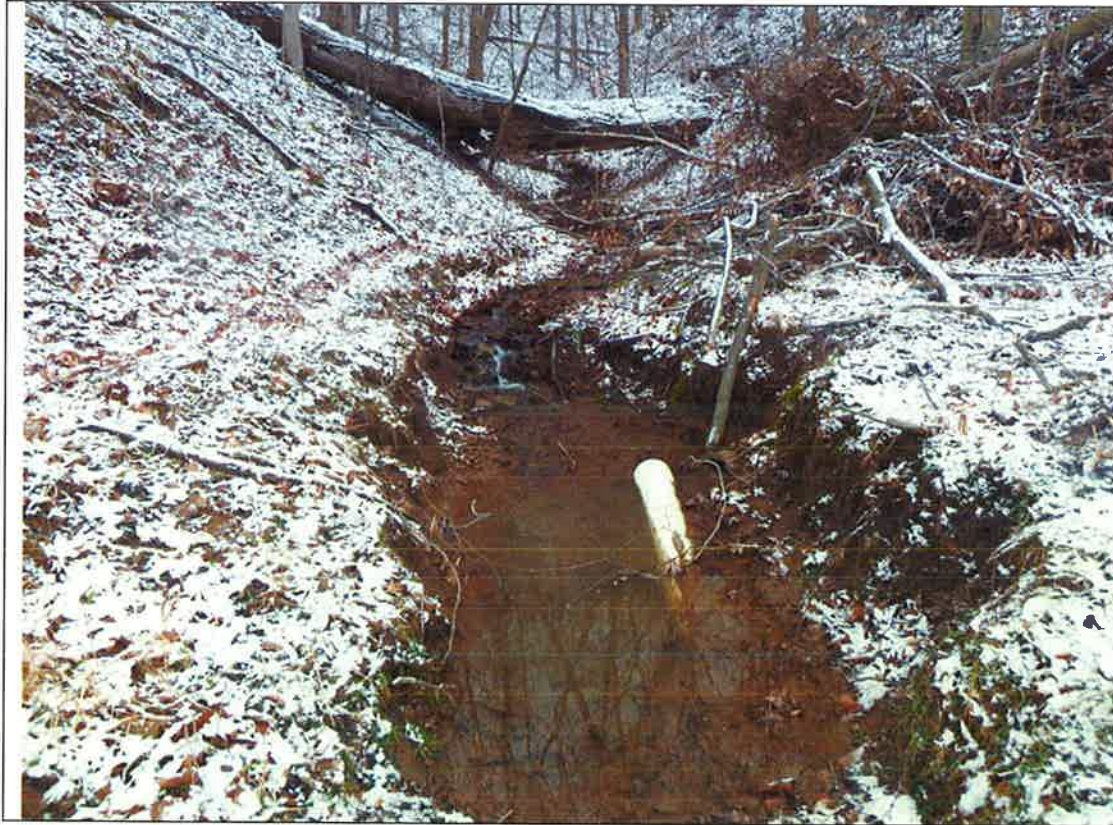
P1000708

WC 4
